# ASSESSMENT OF SEISMIC FAULT RUPTURE, GROUND DEFORMATION AND SUBSIDENCE HAZARDS at the Ford-Otosan Automobile Assembly Plant Koçaeli, Turkey

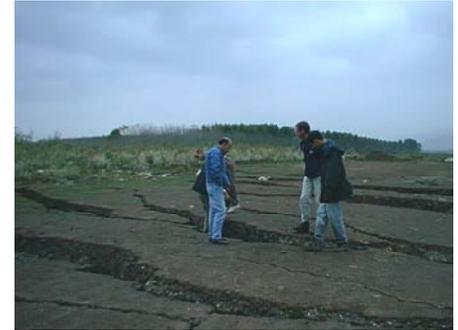
We reviewed and mapped liquefaction features

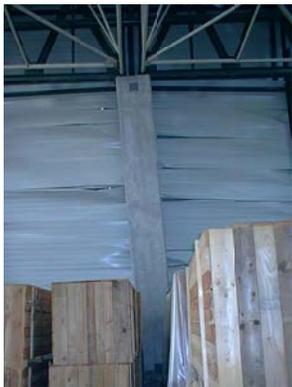
We mapped structural deformation due to subsidence

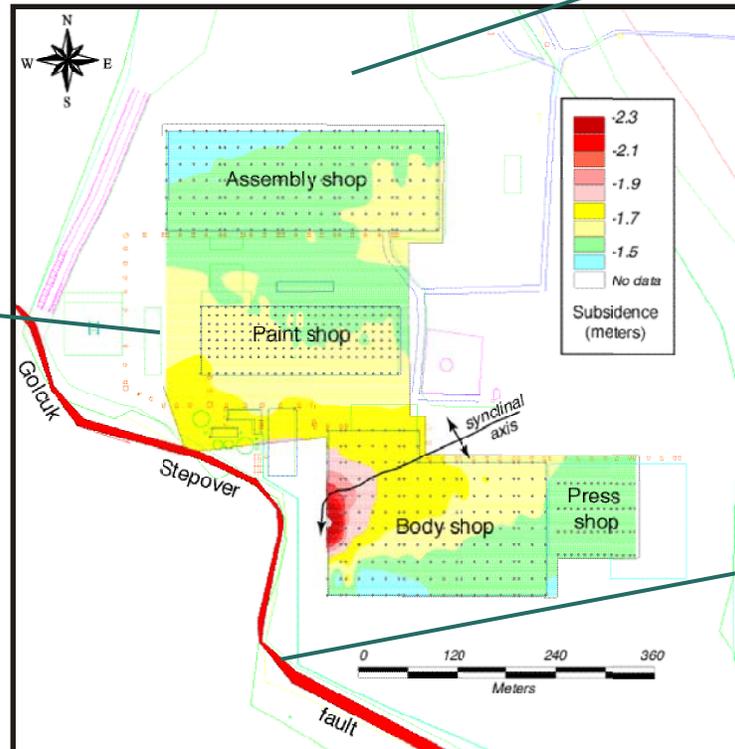
Geologic field mapping of the fault zone and quantitative analysis of subsidence in the area of the buildings

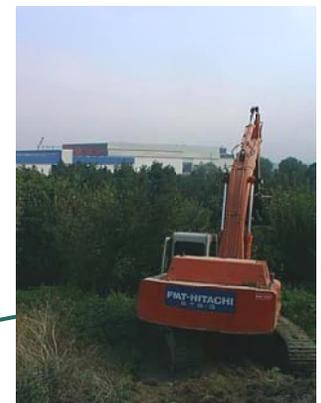
We performed paleoseismic trenching
