FAULT HAZARD INVESTIGATION AND MITIGATION PLAN for Tejon Ranch's Centennial Specific Plan, Los Angeles County, California

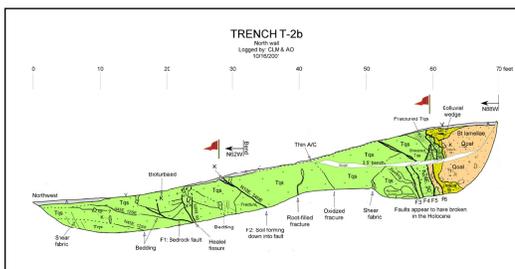
Log for trench T-2b showing two active faults
