FAULT HAZARD SCREENING STUDY

for New Buildings at San Bernardino Valley College, San Bernardino, California

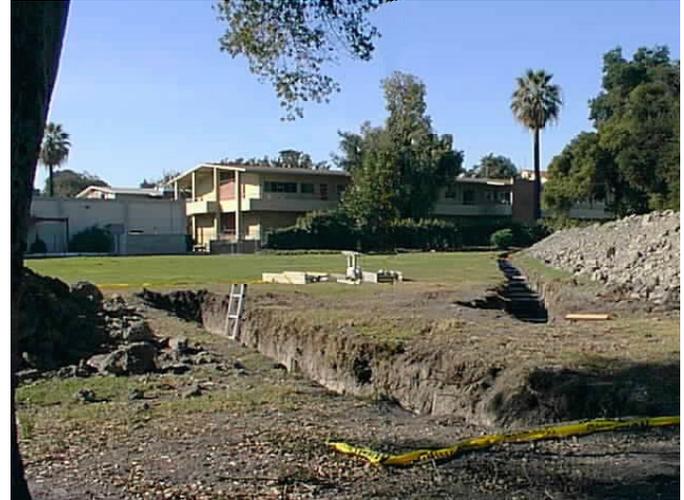
Photo showing Trenches ECI-2 and ECI-2b excavated at the site of one of five new proposed buildings at the San Bernardino Valley Community College campus

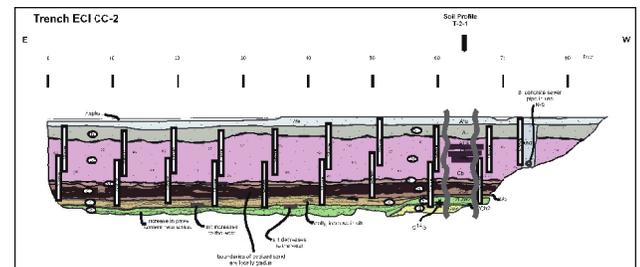
Log of Trench ECI CC-2 excavated to investigate the location of the proposed child-care facility
