FAULT HAZARD INVESTIGATION OF THE MOTAGUA FAULT

for a Proposed Liquefied Natural Gas Terminal Facility in Honduras, Central America

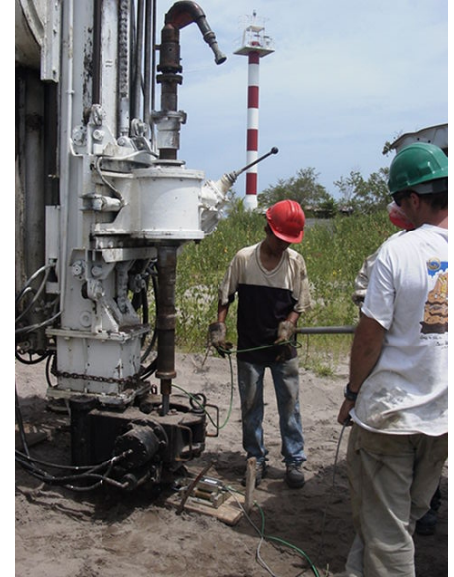
The Cone Penetration Tests were advanced into the ground using a track-mounted drill rig modified to accommodate the CPT rods. Digital measurements were recorded by and saved to a field laptop computer. Processing of the CPT data was done in the evenings allowing us to modify our field program as necessary in response to the day's findings.

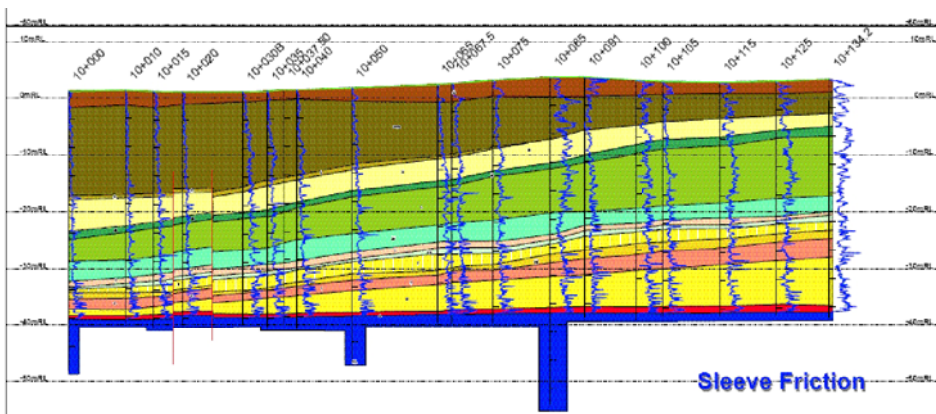
From the Landsat images and Corona aerial photographs of the site vicinity we identified several lineaments in the area, including some very close to the site. The images also showed that the site sits on very young sediments; as a result, we could not preclude the possibility of recently active faults in the shallow subsurface, buried under the young deposits. Unusual landforms suggested the area has experienced recent tectonism (folding and/or faulting), and possibly lateral spreading. For the field portion of the study, we assembled a multinational team of drillers and engineers that emplaced more than 50 CPTs into young, saturated sandy deposits. The CPTs were pushed to a depth of at least 40 meters, and into a distinctive clay layer that we used as a stratigraphic marker to determine whether or not there were vertical offsets in the stratigraphy between two contiguous CPTs. Additional CPTs were emplaced where these breaks were observed to more closely determine the location of the inferred faults. The offsets were traced upward to at least the bottom section of the overlying sand, and some could be extended upward to near the ground surface. Horizontal displacements

were indicated by the variation in the thickness of the beds in the sandy section. From these results we concluded that the site is either 1) underlain by active faults,

2) underlain by a thick section of liquefiable sediments that have experienced several episodes of lateral spreading, or 3) sits on a large shallow-dipping slump that developed as a result of sediment loading of the soft underlying clay. Additional studies to determine the cause of these features were recommended.

Cross-section of the site using the sleeve friction records (blue lines) to interpret the subsurface stratigraphy and offsets (vertical red lines). The site is underlain by interbedded sand and silty sand to a depth of about 40 meters. This package sits on clay (blue unit at bottom), a distinctive geologic unit that was used as a stratigraphic marker.
