# GEOLOGIC HAZARD SCREENING for Potential Power Plant Sites and Liquefied Natural Gas (LNG) Terminal Facilities Baja California, Mexico

## PROJECT DESCRIPTION

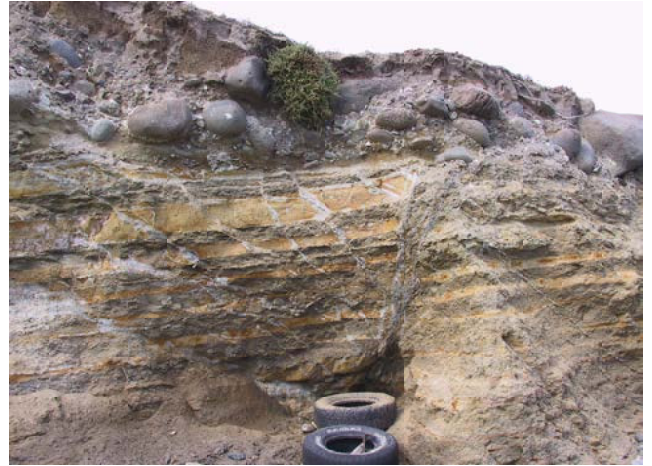
Potentially active fault posed a serious constraint at this potential site.

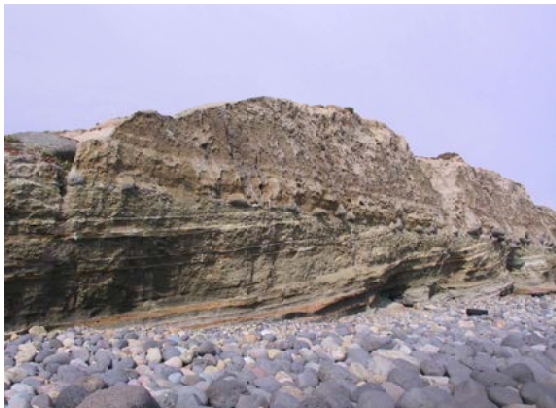
Good exposure of an undeformed marine terrace across a potential site.

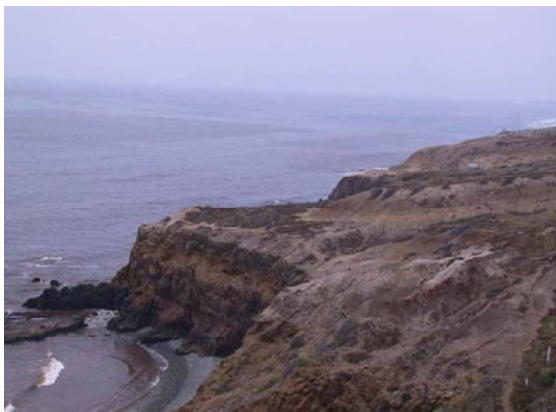
Coastal bluff landsliding poses a serious constraint at this potential site.
