# FAULT HAZARD ASSESSMENT INVESTIGATION for the Proposed Costa Azul LNG Terminal Facility Baja California, Mexico

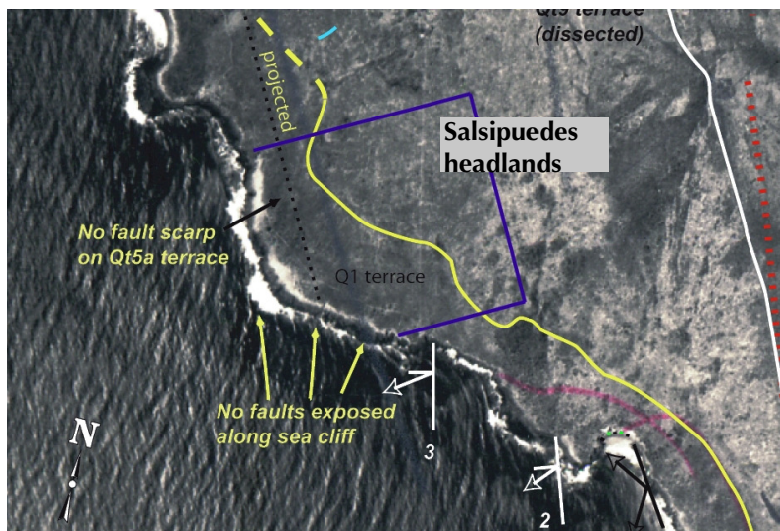
*Earth Consultants International* conducted a fault investigation to assess the potential for surface faulting for a proposed liquefied natural gas (LNG) facility at Costa Azul, Baja California (Figure 1). The site lies ~75 km south of the US-Mexico border on the actively deforming Salsipuedes headlands (Figure 1). The most significant potential seismic source in the vicinity is the Agua Blanca - Descanso fault zone, which lies 5 to 12 kilometers offshore and has a slip rate of 4 to 5 mm/yr. An assessment of significant faults within 100 km of the site was conducted and exposures along the sea cliff of the La Jovita (Figure 2) and Point faults (Figure 1, faults 3 and 2) were reviewed to evaluate whether the faults cross the site.

Figure 1. Aerial photograph of the site (outlined in dark blue) with paleo-shorelines denoted by yellow and white lines. Nearby faults include the Cove (1), Point (2), La Jovita (3) and the projected Baja Mar fault (dotted line).

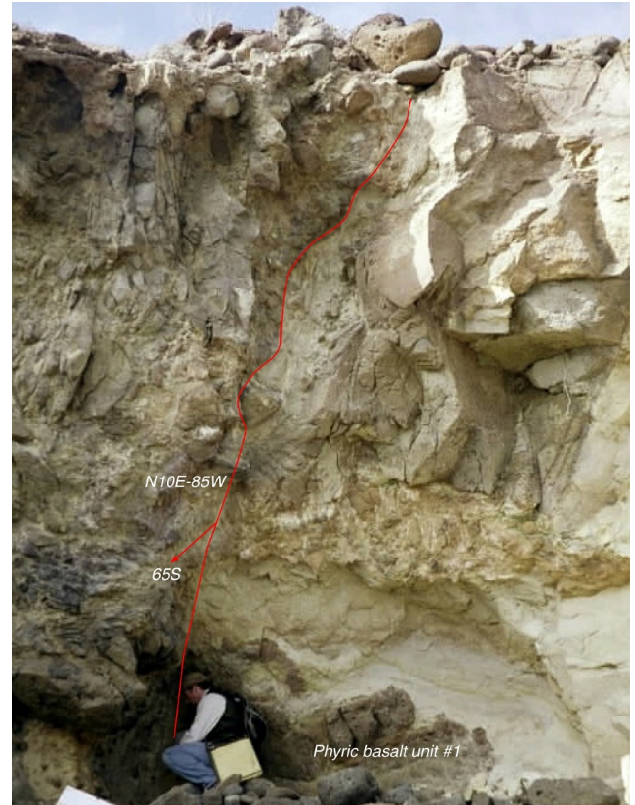
Figure 2. Sea cliff exposure of the La Jovita fault.

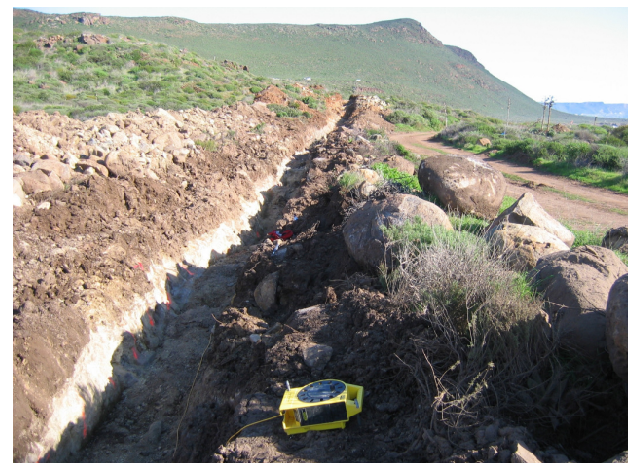
An 850-meter long trench was excavated across the site exposing marine terrace deposits overlying Miocene volcanic rock (Figure 3). The excavation exposed the Point fault at the eastern end of the site and several minor faults on the western side, but the La Jovita fault was not observed. The overlying marine terrace was not offset by any of these faults. Our assessment of the marine terrace ages indicate that these faults have been inactive in the past 80,000 years, although they probably were active earlier in the Quaternary. The primary geologic hazard is the possibility of strong seismic shaking from the nearby Agua Blanca - Descanso fault zone. Rupture of one of the faults associated with uplift of the Salsipuedes headlands (e.g., Baja Mar fault) is also possible, although not as likely, due to their low slip rates.

Figure 3. Fault trench exposing marine terrace (boulders) overlying basalt.
