# SEISMIC HAZARD INVESTIGATION FOR THE NEW NORTH HAIWEE DAM #2 Owens Valley, California

## **PROJECT DESCRIPTION**

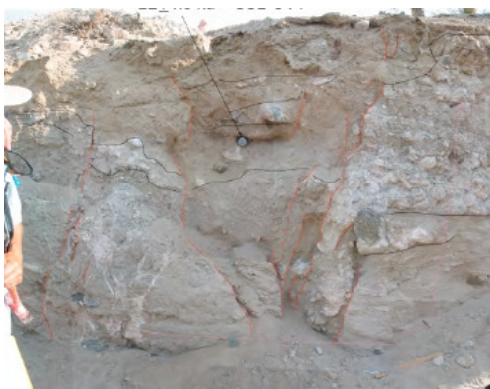
Left: Photo of the upper part of the fault zone showing the fault graben and the colluvial infill that has not been faulted.

The information developed in this study suggests that the fault at the proposed dam site has repeatedly ruptured to the surface in the past 100,000 years, but has not ruptured through a fault graben that filled with colluvium since the last event. The colluvial deposits were estimated to be about 22,000 years old. Based on this finding, the fault was determined to pose a very low risk of surface rupture through the dam area.

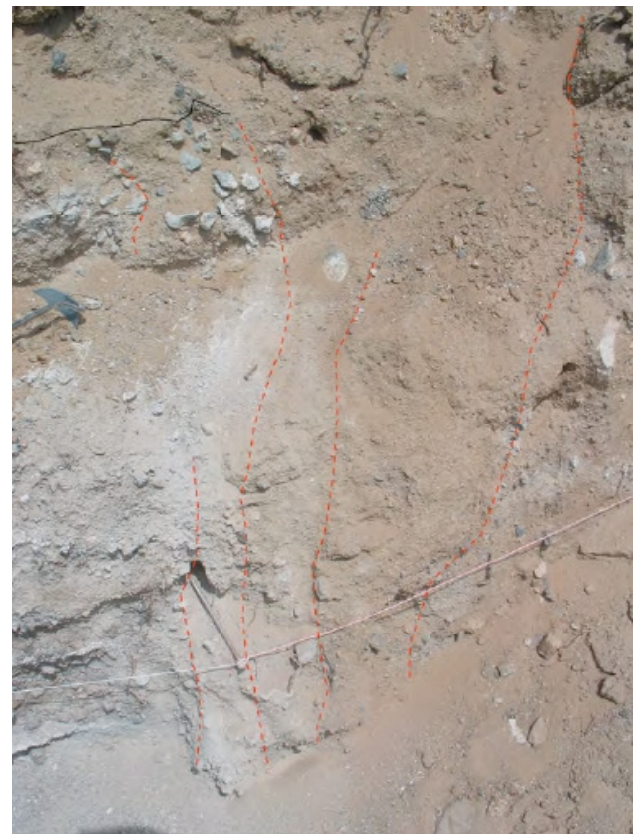
Top: Photo of the entire fault zone exposed, showing the truncation of the Stage IV carbonate horizon. Based on the carbonate stage development, we estimated these deposits at ~100,000 years old.
