QUANTITATIVE FAULT RUPTURE CHARACTERIZATION FOR DESIGN OF THE BORINQUÉN DAM, PANAMÁ CANAL EXPANSION PROJECT, PANAMÁ

PROJECT DESCRIPTION

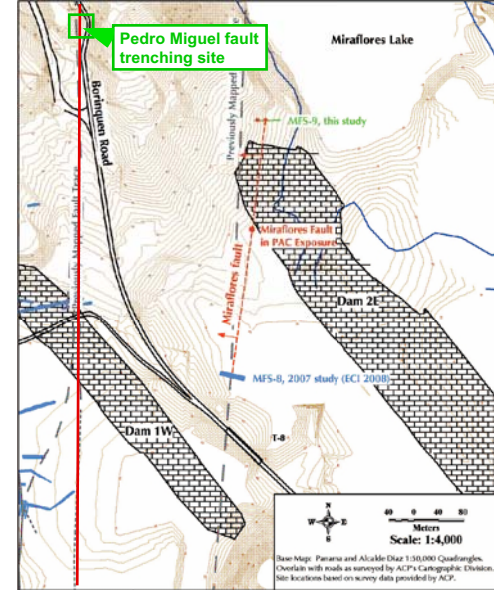
Trenching location within the center of the proposed Borinquén Dam, adjacent to Miraflores Lake. The Miraflores fault was also investigated in a parallel study.

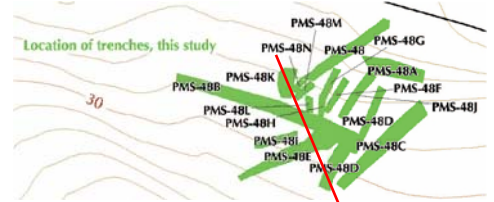
Map of trenches excavated.

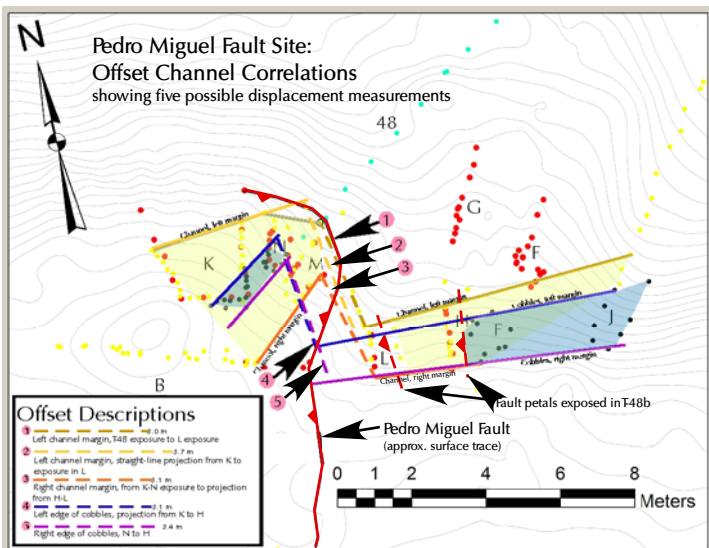
Map of the offset channel margins, showing several channel reconstruction alternatives. The best fit reconstruction was 3.0 ± 0.2 m.

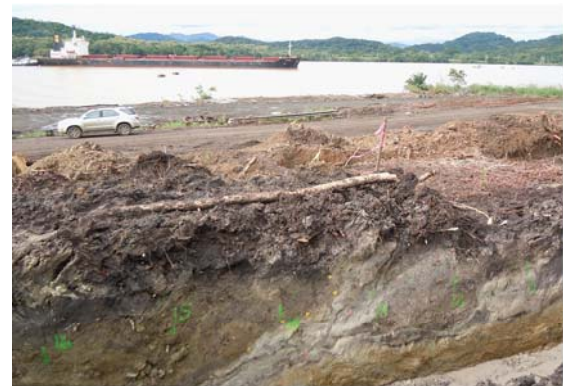
Trench exposure (right) of the most recent event on the Pedro Miguel where the the fault ruptures to the surface, forming a mole track that is still preserved topographically. The channel deposits that we mapped across the fault are shown on the left, about 3 m before they cross the fault and are subsequently offset (left).
