ASSESSMENT OF SEISMICALLY INDUCED FAULT AND FOLD DEFORMATION POTENTIAL at the AKSA Acrylic Facility, Yalova, Turkey

PROJECT DESCRIPTION

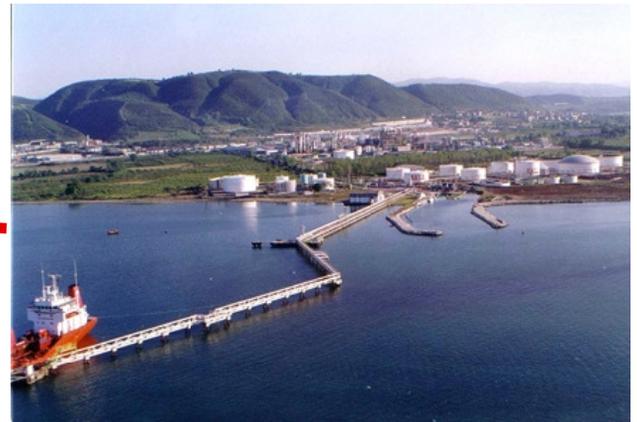
The AKSA facility suffered partial failure of the mole, loss of a docking dolphin, failure of several storage tanks, and cracking and tilting of several production structures.
