FAULT HAZARD INVESTIGATION

LOS ANGELES UNIFIED SCHOOL DISTRICT'S Belmont Learning Center, Los Angeles, California

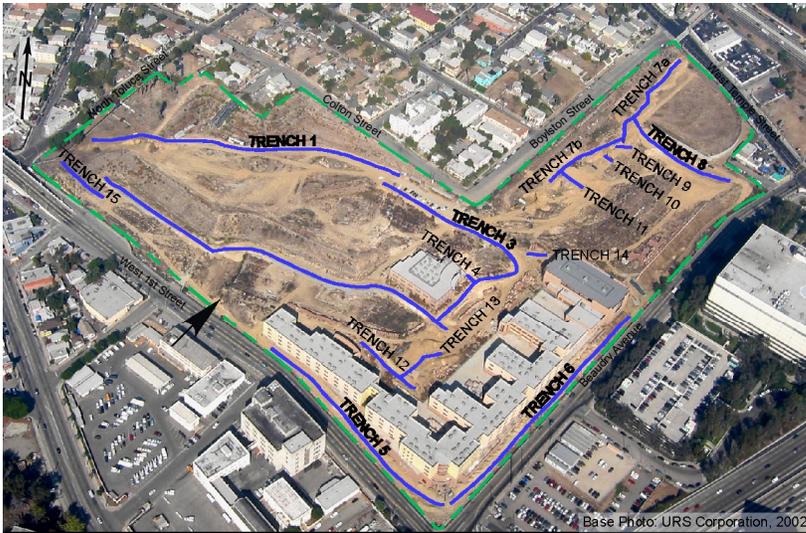
Aerial photo of the nearly completed Belmont Learning Center showing with blue lines the locations of fault trenches.

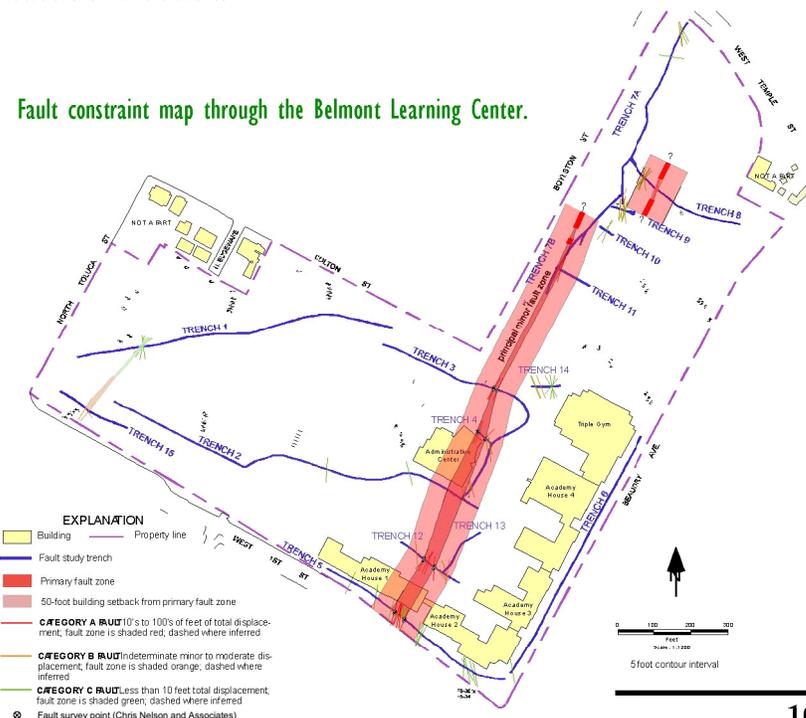
Fault constraint map through the Belmont Learning Center.

We began the study by trenching across the fault that had been inferred from the geophysical survey. Trench 1 showed that there was no fault there. The project was then expanded to include all other areas of the campus in an attempt to preclude faults as a hazard anywhere within the school site. This resulted in the discovery of a prominent fault trending NNE and passing through the already constructed Administration and Academy House 1 buildings. Because all surficial deposits and soils at the school site had been removed by grading, we were unable to document when the fault moved last. Attempts to study the fault's displacement history offsite, in a property to the south of the school, were unfortunately also unsuccessful. Within the site, we were able to resolve the total slip across the fault, and make estimates of slip per event. Though it was our opinion that the fault was very likely not active, the LAUSD made the decision to demolish the buildings that had been built above the trace of the fault, and replace them with buildings off the fault. The Edward R. Roybal Learning Center, as it is now known, opened in 2008.

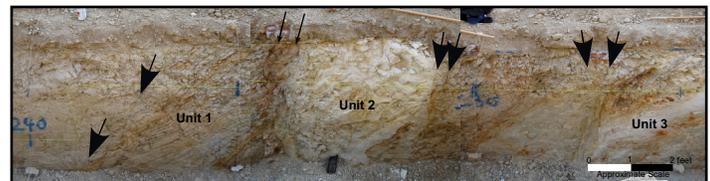
Trench exposure of the 7-meter wide fault zone through the site. Black arrows show faults.
