TECTONIC GEOMORPHIC RECONNAISSANCE OF the Pedro Miguel, Azota, Miraflores, and Other Faults Panamá Canal Area and Vicinity, Panamá

PROJECT DESCRIPTION

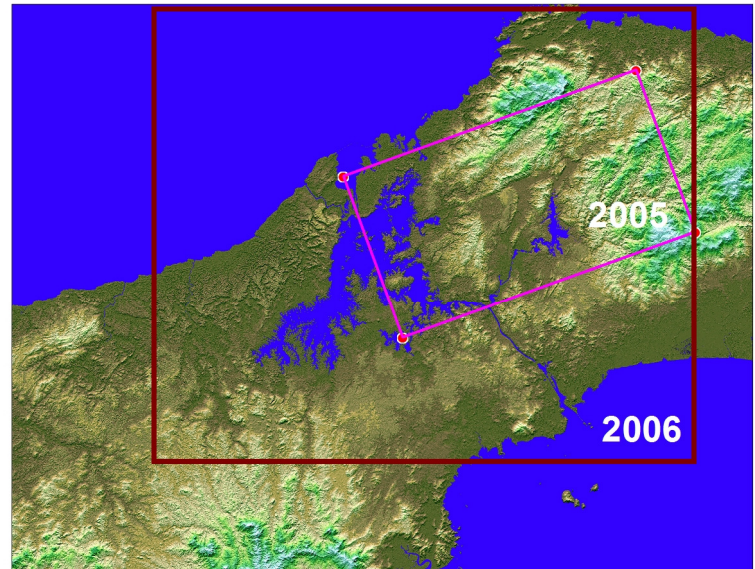
Digital elevation map of central Panamá showing the initial project (2005) and this project's (2006) study areas.

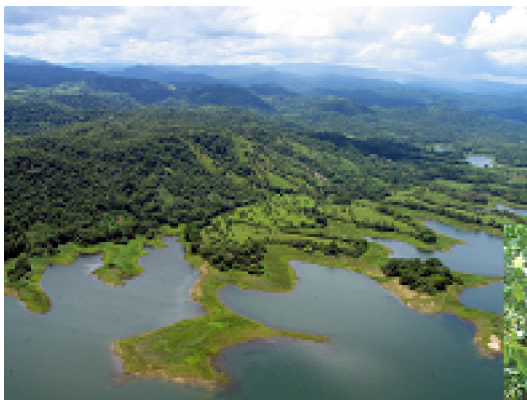
Prominent fault-controlled landscape east of Lake Madden (above).

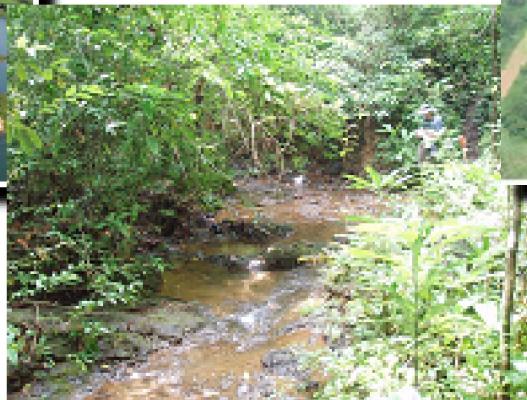
Ten-meter stream offset across the Azota fault that was revealed during field reconnaissance mapping (right).

Deflected drainage network across the Pedro Miguel fault in Cocli, showing a potential trenching site where we later completed a quantitative study (right).
