Tectonic geomorphic and paleoseismic investigation of the Gatún fault in central Panamá

Gath, Eldon (1), Tania Gonzalez (1), Thomas Rockwell (1), and Pastora Franceschi (2)

Key words: Paleoseismology, neotectonics, Panamá, seismic hazard

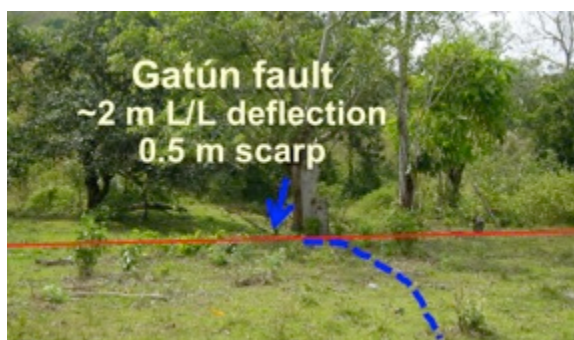
Fig. 3: Stream deflection of ~2 m left-lateral across the Gatún fault. This deflection is uphill to the regional drainage (to the left in the photo).

A tectonic geomorphic strip map was prepared of the 40 km segment of the fault between Gatun Lake, east to the Chagres River (Fig. 1) (ECI, 2005). On the ground, the surficial geomorphology is equally spectacular with all drainages across the fault left-laterally deflected, stream knickpoints, and small scarps across fan surfaces. The smallest left-lateral deflection observed was ~2 m, with a 0.5 m vertical scarp, while the largest was ~150 m with a scarp over 10 m high (Figs 3, 4, & 5).

Based on the strip map and field reconnaissance, several locations were considered for the trenching study. Shallow groundwater was a constraint at the site in Fig. 3, while site access was a constraint at the pottery site (Figs. 5 & 6). A site about 300m east of Fig. 4, and geomorphically similar to the Fig. 5 site, was chosen for the trenching study (Figs. 7 & 8). At this site, the primary objective was to determine a Holocene slip rate by accurately measuring the offset and determining the age of a channel that had been left-deflected ~20 m across the fault.

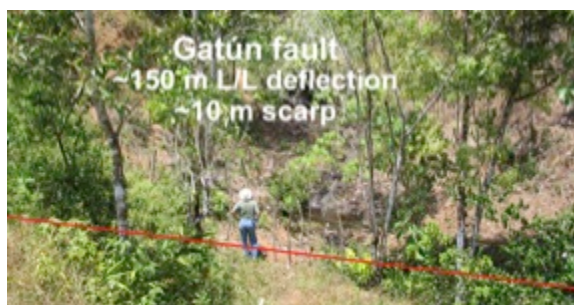
Fig. 4: Left-lateral stream deflection of ~150 m (well outside the photo view) across the Gatún fault east of Gatún Lake. An increased deflection of larger rivers is an indicator of progressive tectonic offsets.

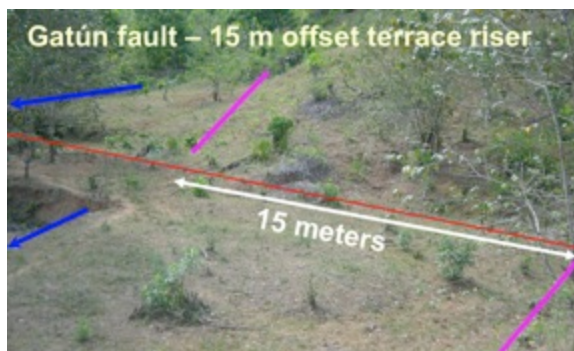
Fig. 5: Sharp stream deflection (blue lines) of ~10 m left-lateral across the Gatún fault east of Gatún Lake. Terrace risers (purple lines) are offset 15 m. Exposed in the terrace deposits is a piece of pottery (Fig. 6).

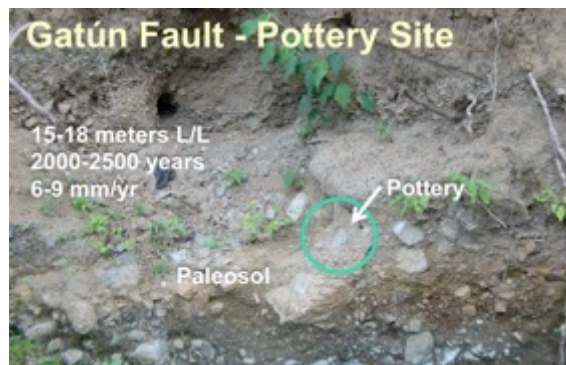
Fig. 6: Large pottery fragment exposed ~1 m below the surface, lying on top of a buried paleosol within the offset terrace deposits. Assuming that such pottery was first found in Panamá <2500 years ago, its presence incorporated into the abandoned terrace surface indicates that it has been offset equivalently to the terrace riser, yielding a 6-9 mm/yr slip rate.

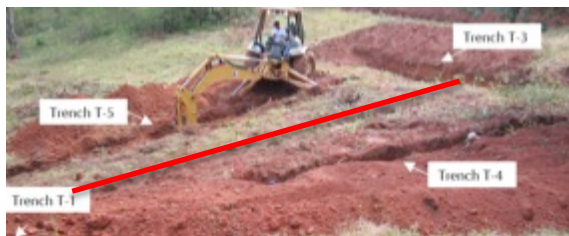
Fig. 9: Trenching parallel to the fault (red line) to look for younger channels that would indicate smaller offsets to help confirm the long-term slip rate calculated from the Trench T-1 offset of the ~3 ka basal sediments (Fig. 10). No additional channels were found.

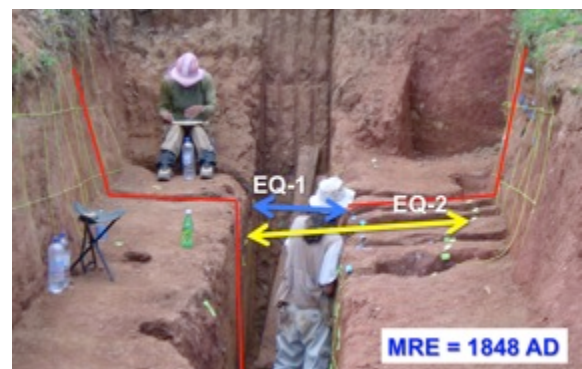
Fig. 12: Hand excavation of small trenches into the eastern bench of Trench T-3 allowed us to define and measure the fault displacement for the most recent (blue flags) and penultimate (yellow flags) events based on the offset of discrete channel margins. The MRE was measured at 0.7 ± 0.2 m and the penultimate event a cumulative 1.4 ± 0.3 m. The ~500 year third event was displaced beyond the 2 m exposure afforded by the bench.
