# PALEOSEISMIC HAZARDS EVALUATION of the Gatún and Limón Faults Panama Canal, Panama

## PROJECT DESCRIPTION

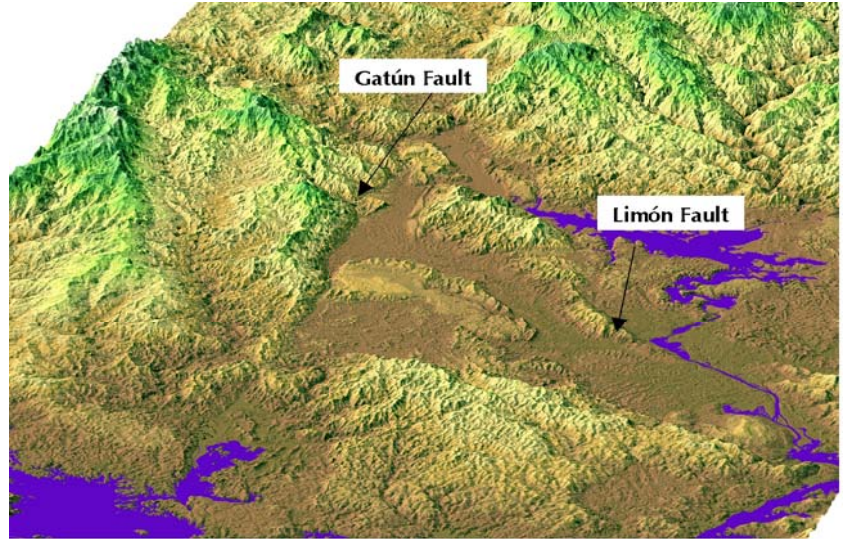
The geomorphology of central Panama, as illustrated in this DEM image, exhibits the appearance of 20 km of left-lateral extension across the Gatún fault and several secondary accommodation faults. Gatún Lake and dam (lower left) are a major part of the Canal waterway, while Lake Madden and dam (upper right) form a major water supply reservoir.

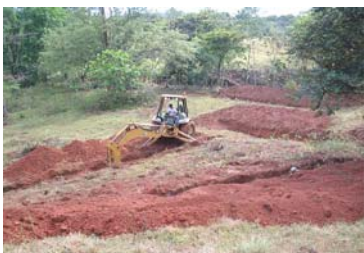
3-D trenching of a feeder channel across the Gatún fault to measure slip per event and timing of past events.

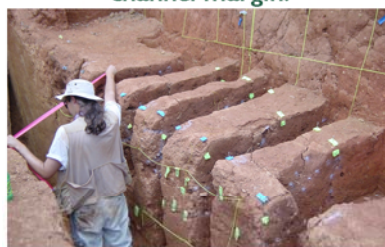
2-D and 3-D trenching of the Gatún fault to measure fault displacement of a 2500-3000 ka channel margin.

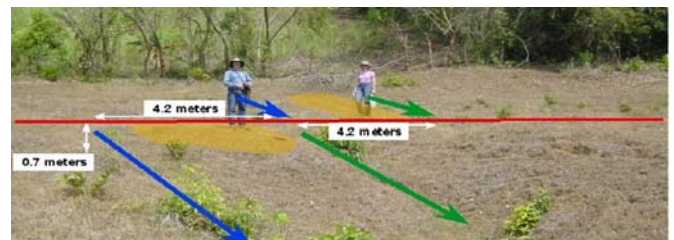
4.2 m offset of two parallel drainage channels along the Limón fault.
