EARTHQUAKE HAZARD STUDY for the Corning Taichung and Tainan Plants

PROJECT DESCRIPTION

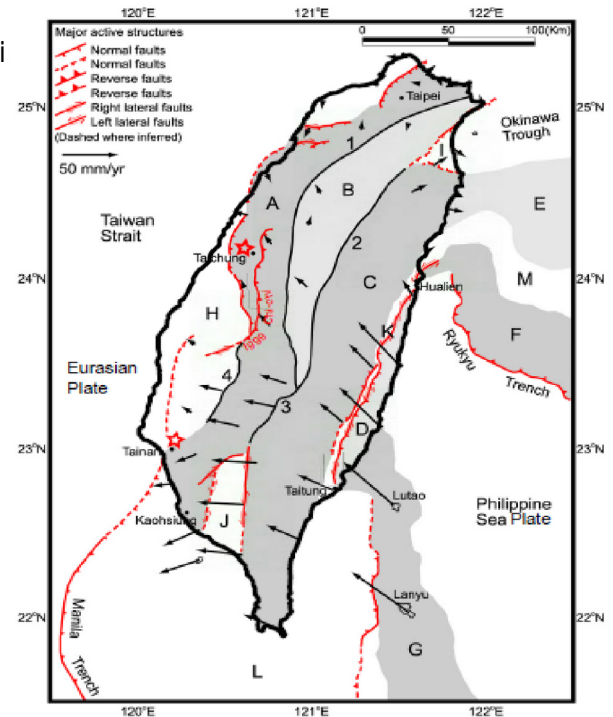
Figure 1 (above): Neotectonic map of Taiwan. The two plant sites are located with the red star. Arrows show velocity vectors measured by GPS data normalized relative to the relatively stable Eurasian Plate
