PEER REVIEW PANEL FOR LANDSLIDE MITIGATION AT THE OCEAN TRAILS GOLF COURSE Rancho Palos Verdes, California

PROJECT DESCRIPTION

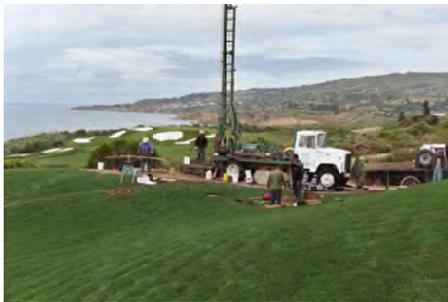
Core drilling at Ocean Trails (left).

The Peer Review Panel reviewed the extensive geotechnical documentation that had been created over 20 years of studying the site. The Panel conducted its own field reconnaissance and mapping, including rappelling down the sea cliff to map, measure, and sample the exposed strata. Four additional borings were drilled and cored at key locations where the two interpretations differed to bring hard data to bear on differentiating between them. These borings were installed with groundwater monitoring piezometers and slope movement inclinometers for future monitoring. After all the existing and new data were reviewed and analyzed, the Panel prepared a review report and held several meetings with the two parties to share the results and help them to understand the differences. The work of the Panel ultimately had two cycles, very similar in scope, as both parties continued to disagree, and more work was done on both sides, including more drilling. Although eventually neither side was pleased, portions of the project were allowed to move forward, albeit with a different design.

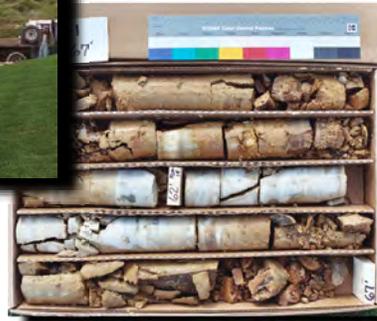
Example of the drilling core collected (right).

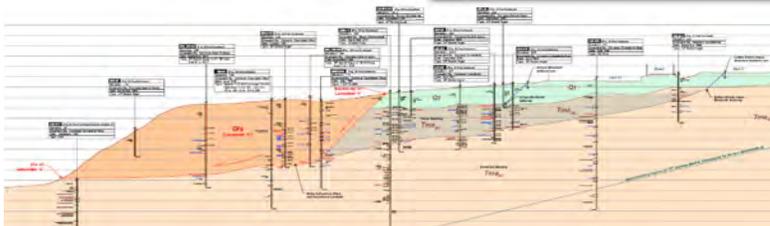
Cross-section through Landslide A.
